**Final Environmental Assessment
and
Finding of No Significant Impact
for the
Turley-Manzanares Acequia
Rehabilitation Project,
San Juan County, New Mexico**

25 September 2006

**U.S. Army Corps of Engineers
Albuquerque District**

**Blue Earth Ecological Consultants, Inc.
1345 Pacheco Street
Santa Fe, NM 87505**

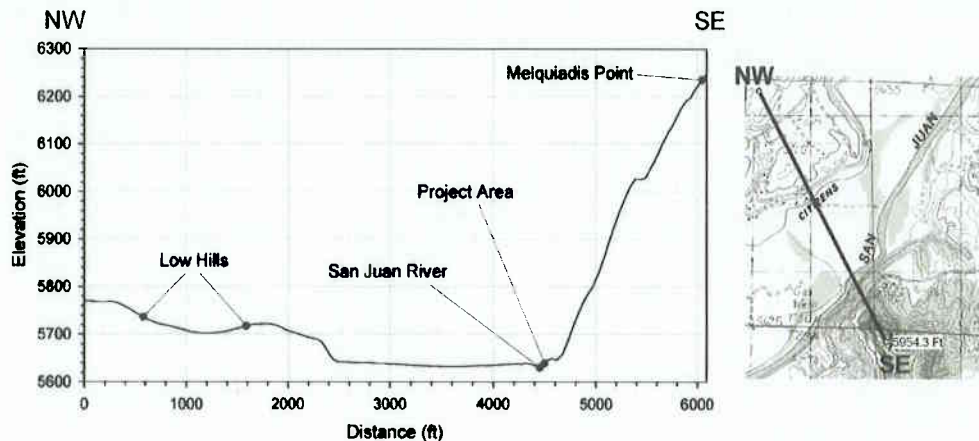
Figure 3.
Elevation
profile through
the project area.

The project area is located in the canyon of the San Juan River about 14.3 river-miles downstream from Navajo Dam. The heading and ditch are situated at the base of the steep slope of Melquiadis Point on the south side of the river. The opposite side of the river is bounded by a broad, level floodplain that yields on its north side to low, rolling hills (Figure 3).

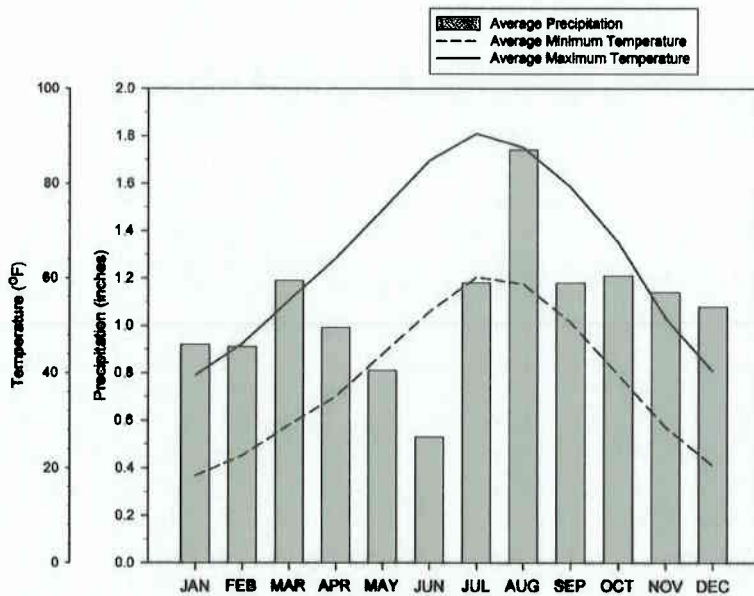
Figure 4. Precipitation and temperature characteristics in the project area.

The project area has a mid-latitude desert climate, with an annual average precipitation amount of 12.9 inches (Western Regional Climate Center, 2005). Precipitation is irregular, but there is typically a pattern of monsoonal rains in July and August as Gulf air masses penetrate into the region (Figure 4). Cyclonic precipitation occurs during winter months, with average annual snowfall in the area of about 11.8 inches. Average diurnal temperature fluctuations of 20°F to 30°F are characteristic of the project area. Summer temperatures are warm and winters are relatively mild (Figure 4).

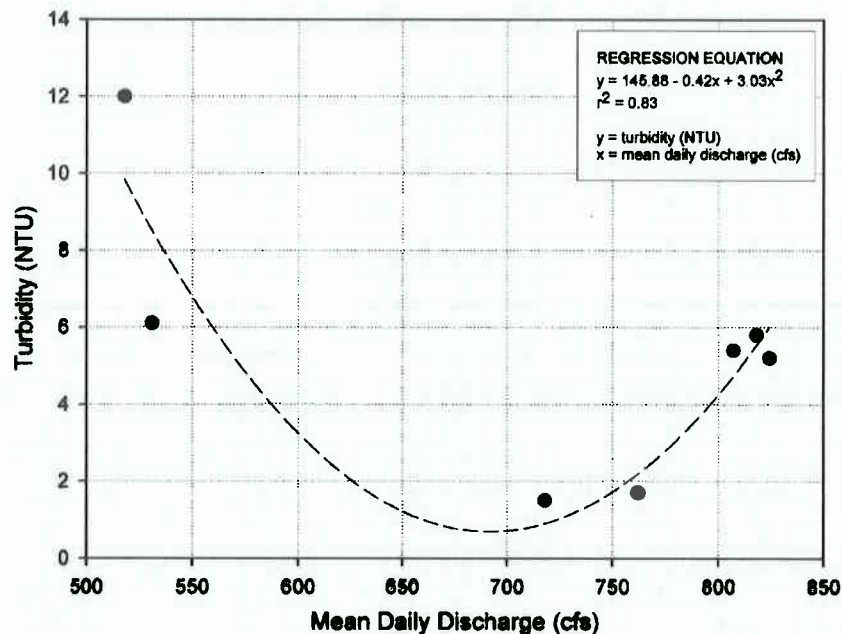
Figure 5. Relationship between turbidity and stream flow in the project area. Turbidity measurements were taken by the New Mexico Environment Department - Surface Water Quality Bureau in 2002 at Blanco, located about 12 miles downstream from the diversion (U.S. Environmental Protection Agency, 2006). Mean daily discharge measurements are from the U.S.G.S. gage at Archuleta.

Turbidity in the San Juan River varies with stream flow, as indicated by data collected in 2002 by the New Mexico Environment Department - Surface Water Quality Bureau. Turbidity in the San Juan River at Blanco ranged from 1.5 to 12.0 NTU between 22 May and 21 October 2002 ($n = 7$; U.S. Environmental Protection Agency, 2006). Mean daily discharge on days of turbidity measurement ranged from 518 to 824 cubic feet per second (cfs), as measured at the U.S.G.S. gage at Archuleta. The relationship between the turbidity measurements and associated mean daily discharge was best described by a second-order regression (Figure 5). This regression equation explained 83 percent of the variation in the relationship between turbidity and stream flow.

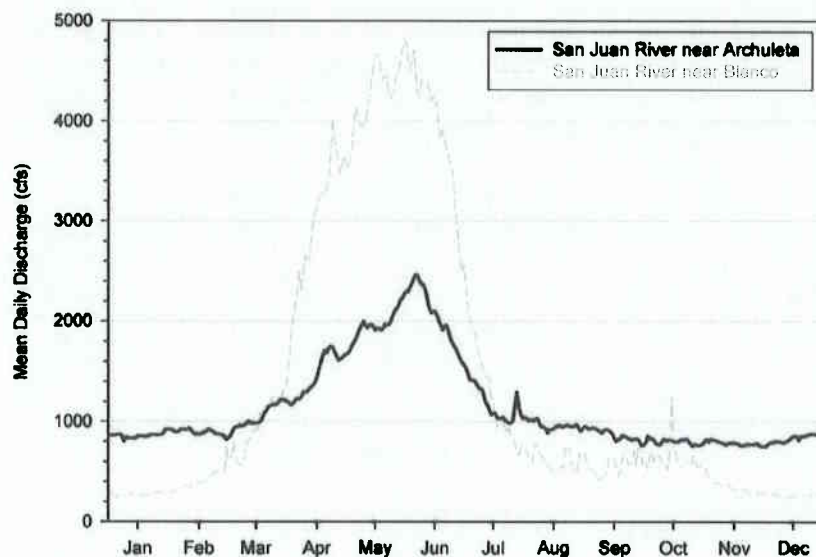
Figure 6. Average annual daily flow in the San Juan River near Archuleta, 1955 through 2004. Average annual daily flow at Blanco, downstream from the project area and below the confluence of Cañon Largo, is also shown.

Average daily discharge of the San Juan River in the project area varies from base flows of about 600 cfs to a peak flows of about 2,400 cfs (Figure 6). Base flow conditions occur from around the end of August through the end of February. Flows become much more variable downstream from the project area due to the influence of tributary inputs and diversion withdrawals (Figure 6). The amount of water withdrawn from the San Juan River at the Turley-Manzanares Diversion is currently not quantified. Water is diverted from the San Juan River and conveyed through approximately 16,500 linear feet of ditch to irrigated agricultural fields before returning to the San Juan River (Figure 1).

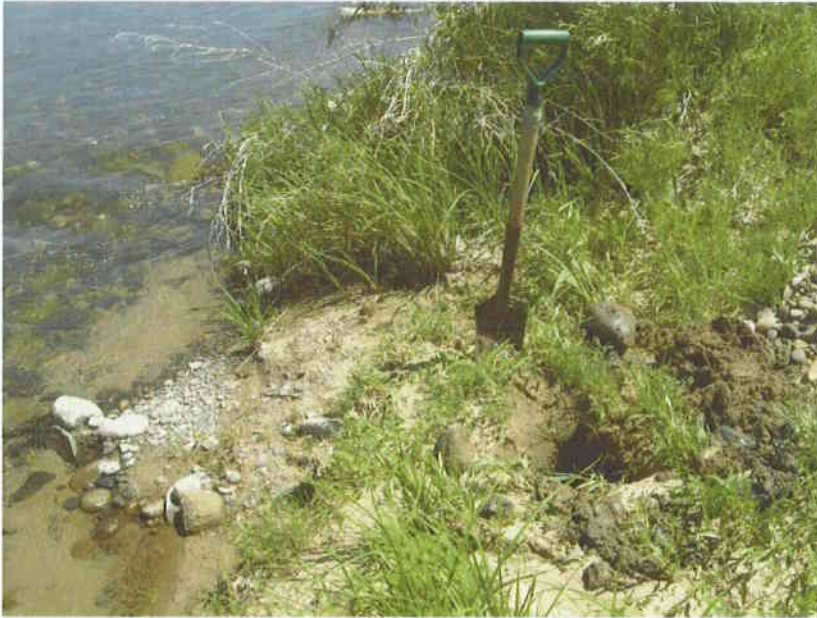
Figure 7. Marginal wetland band along the embankment.

A routine jurisdictional wetland determination and delineation of the project area was conducted on 12 July 2005 pursuant to the 1987 Corps of Engineers Wetlands Delineation Manual procedure (Environmental Laboratory, 1987). Wetlands in the project area were restricted to a narrow marginal band along both the river and ditch sides of the embankment. The average width of the wetland band on the river side of the embankment was 3.1 ft ($n = 8$, min. = 0.3 ft, max. = 6.0 ft). Mean width of the wetland margin on the ditch side of the embankment was 0.8 ft ($n = 8$, min. = 0.2 ft, max. = 6.0 ft). The areal extent of wetlands in the project area was 4,650 ft² (0.11 acres), of which 79 percent was on the river side of the embankment (Figure 7).

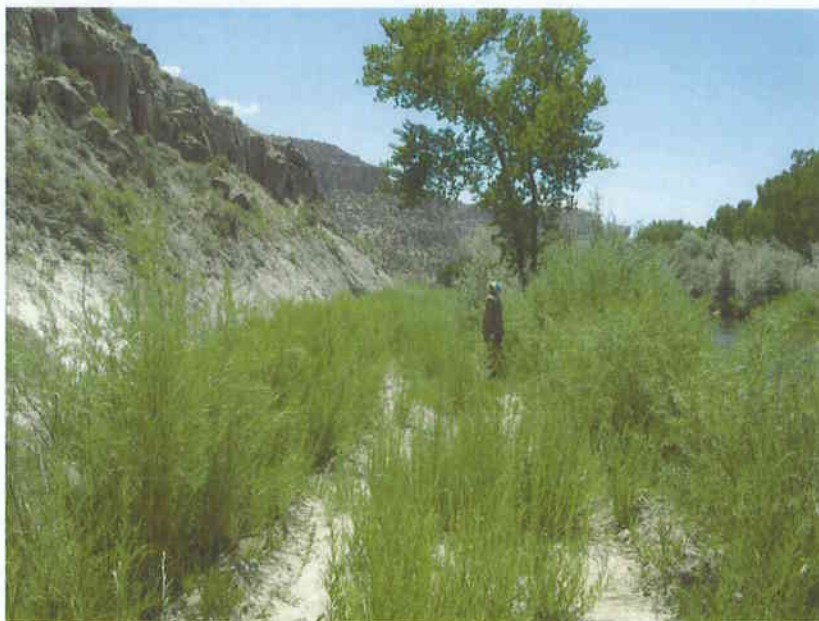
Figure 8. Riparian vegetation on the embankment between the ditch and the San Juan River. River is to the right of the person in the photograph and the ditch is to the left.

There is about 0.47 acres of riparian habitat in the project area. This habitat is located on the embankment that separates the ditch from the San Juan River. Riparian habitat in the project area was characterized by dense stands of young coyote willow (*Salix exigua*) on top of the embankment and coyote willow, Russian olive (*Elaeagnus angustifolia*), and cottonwood along the river side bank of the embankment (Figure 8).

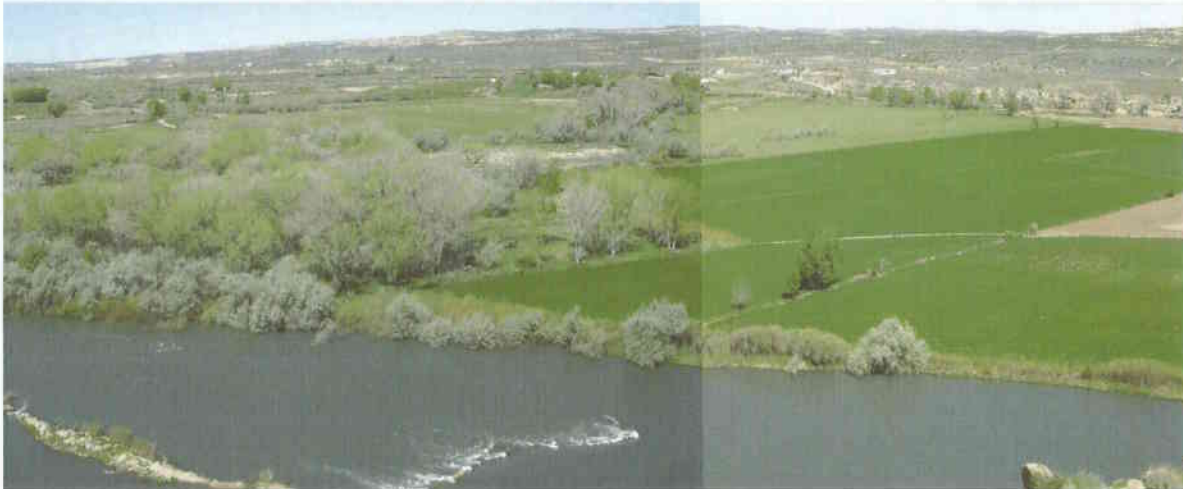
Figure 11. View of the northern bank of the Turley-Manzanares Acequia project area with agricultural fields and riparian forest. Existing diversion can be seen in the foreground. The embankment and ditch appear in lower left corner. Photo taken from overlook on N.M. Highway 511.

The ditch is situated between a steep hill slope on the south and an embankment of fill material on the north. A vehicle track is located on the top of the embankment and leads to the concrete head gate. At the upstream end of the embankment, the diversion groin extends north into the river channel, directing flow into the head gate and ditch (Figures 2 and 11).

Land ownership in the project area is private along both sides of the river. The north side of the San Juan River in the project area is primarily cottonwood gallery riparian forest flanked on the east and west ends by agricultural fields used for growing crops or as pasture for livestock, respectively. Figure 11 shows the riparian forest and agricultural fields at the east end of the project area across from the existing diversion.

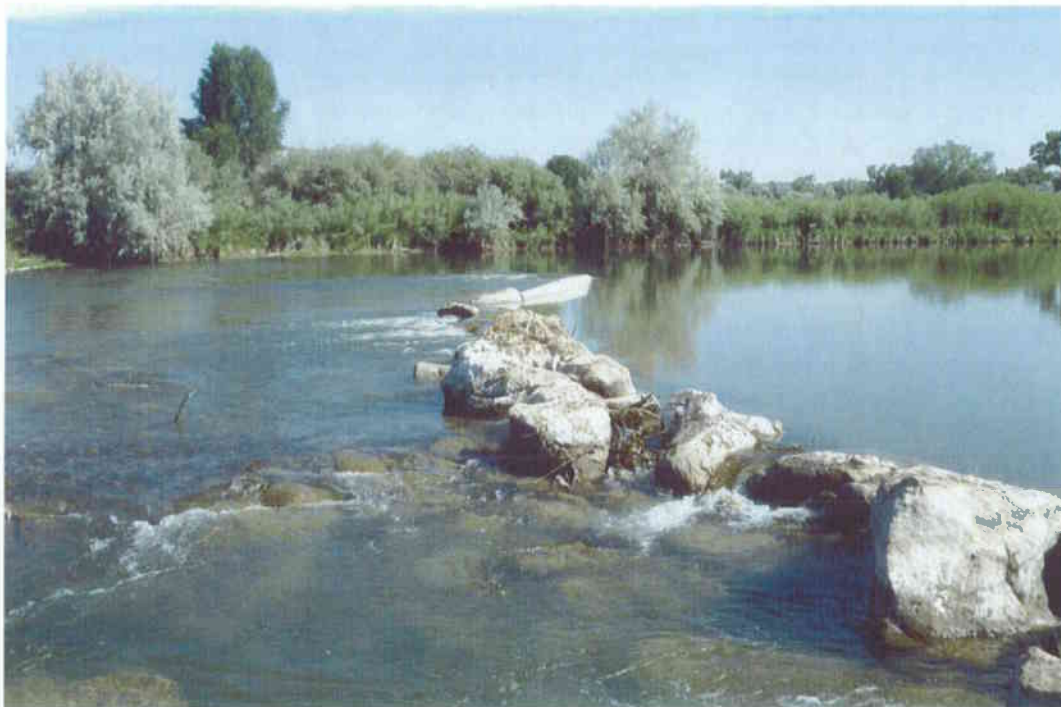
Figure 4. Turley-Manzanares Acequia, Feature 1, diversion dam, photo facing north.
Water flows into acequia to right of dam (July 6, 2005).

Feature 1 was the diversion dam that directed the San Juan River into the canal at its eastern end (Figure 4). The diversion dam was constructed in 1876 (Pat Montoya, personal communication 2006). It was constructed of approximately 12 boulders, each averaging 1.8 m (6 ft) in diameter. Rubble was present among the boulders, though it was evident that high river levels had necessitated reconstruction throughout the use period of the dam. At the northernmost point of the dam, two concrete barricades were present. The diversion dam was situated at a 45-degree angle to the flow of the river, and extended approximately 15.25 m (50 ft) to a point about midway in the river. Rehabilitation of the acequia is expected to impact Feature 1.

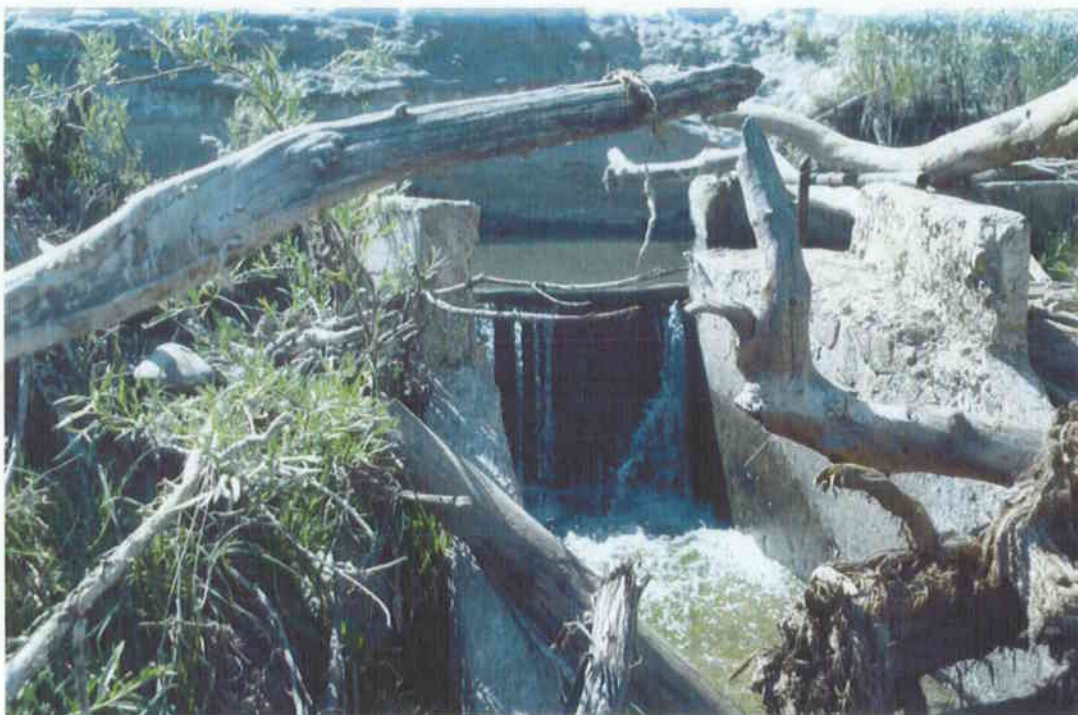
Figure 5. Turley-Manzanares Acequia, Feature 2, drain, photo facing south (July 6, 2005).

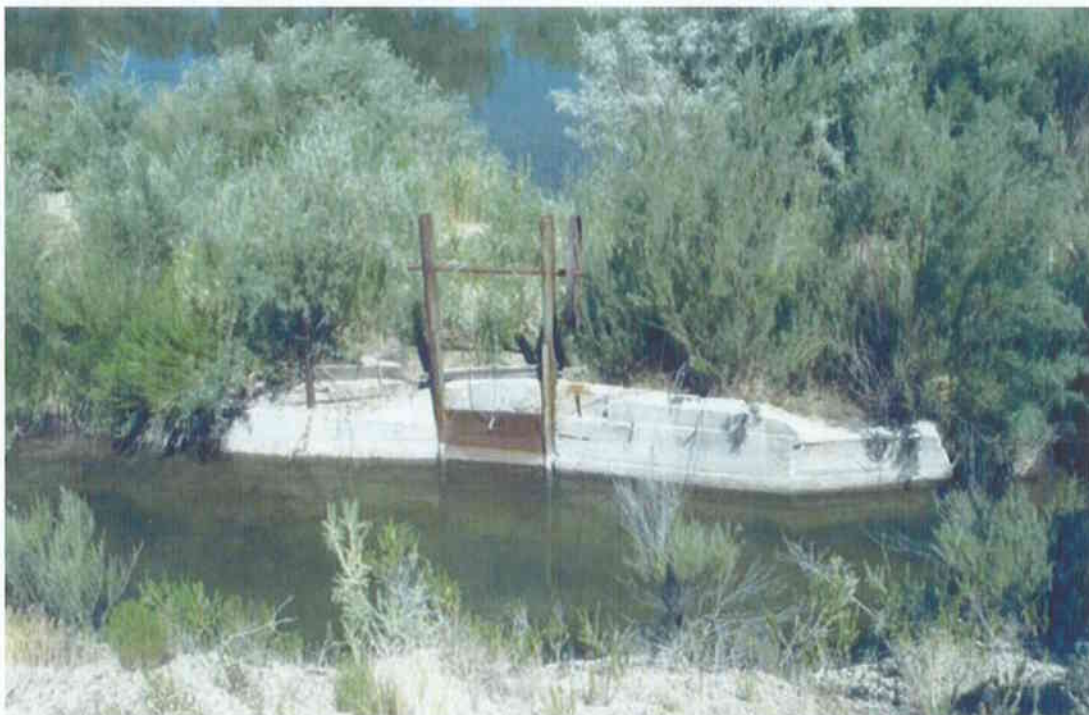
Figure 6. Turley-Manzanares Acequia, Feature 3, hay rake-wheel drain, photo facing north.
Note San Juan River in background (July 6, 2005).

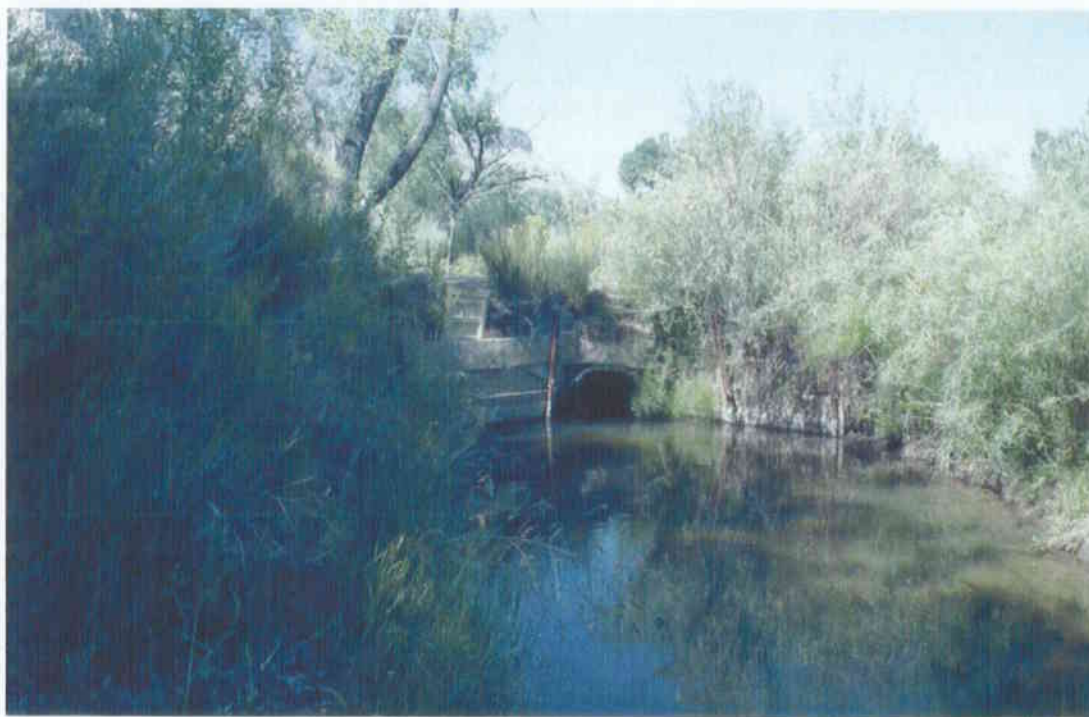
Figure 7. Turley-Manzanares Acequia, Feature 4, culvert, photo facing west (July 6, 2005).

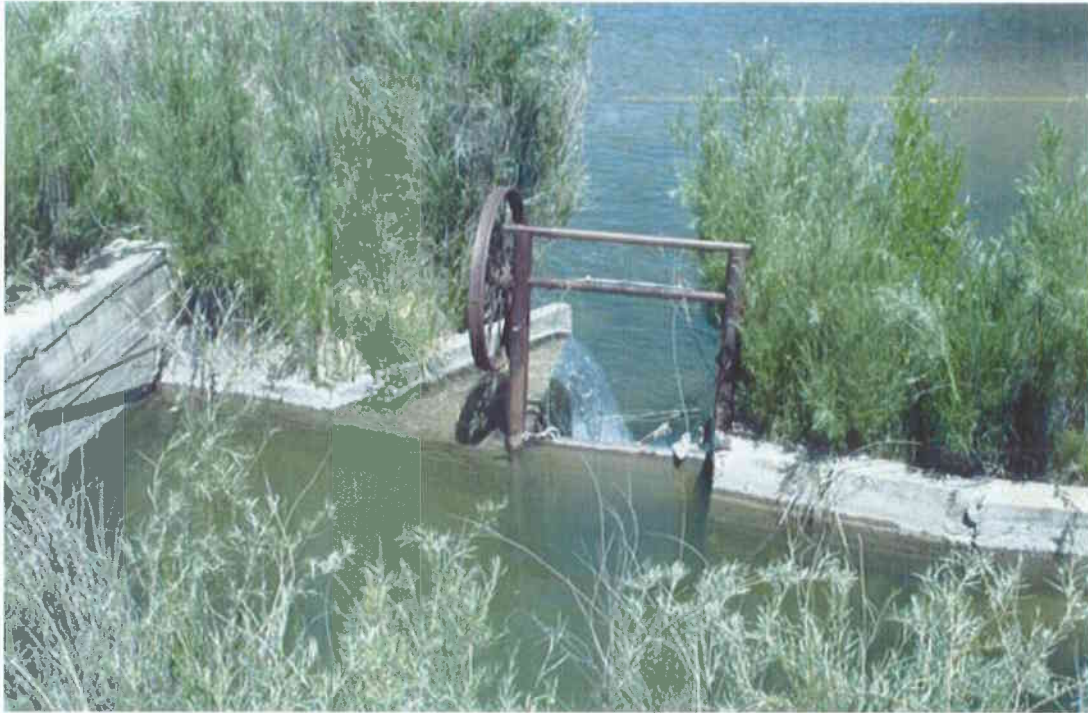
Figure 8. Turley-Manzanares Acequia, Feature 5, hay rake-wheel drain, photo facing north (July 6, 2005).

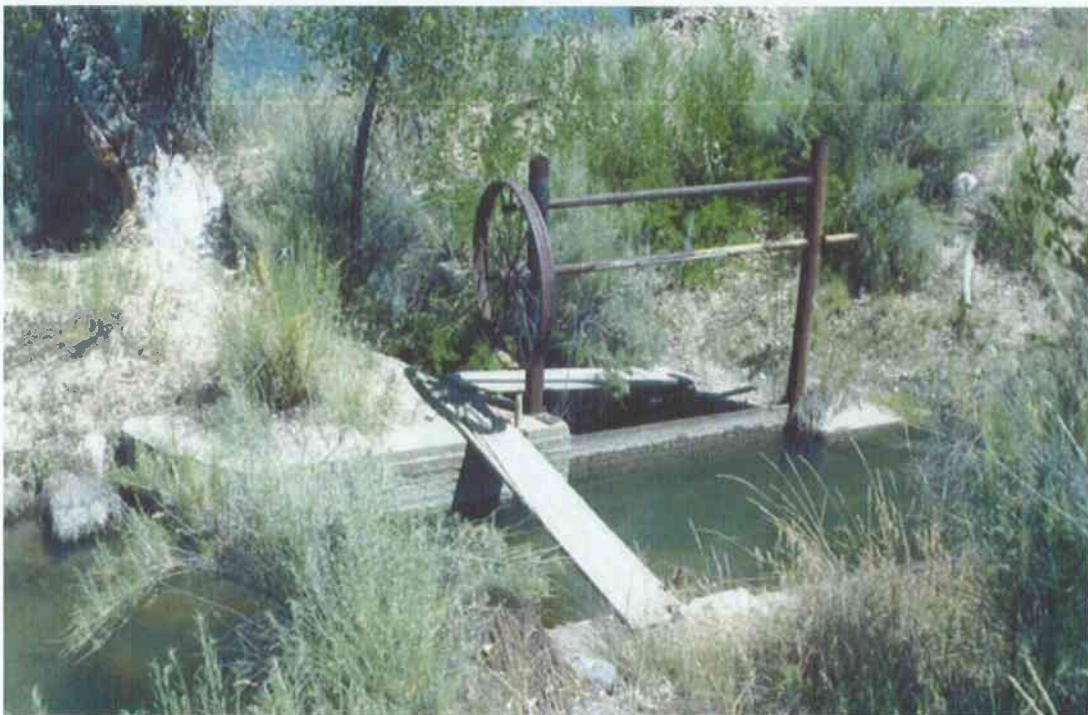
Figure 9. Turley-Manzanares Acequia, Feature 6, hay rake-wheel drain, photo facing north (July 6, 2005).

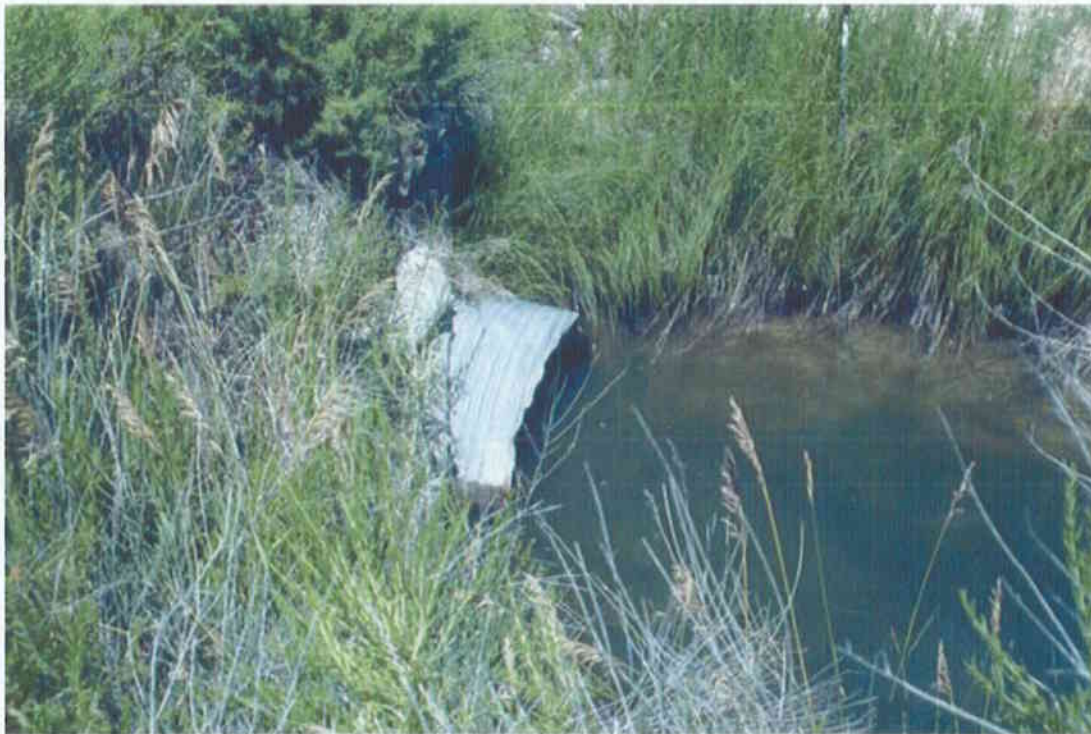
Figure 10. Turley–Manzanares Acequia, Feature 7, culvert, photo facing north (July 6, 2005).

Feature 7 was a culvert constructed of 36-inch-diameter corrugated steel pipe (Figure 10). The culvert was constructed after 1953 (Pat Montoya, personal communication 2006). It conveyed water beneath a two-track road. The length of the culvert was approximately 7 ft.

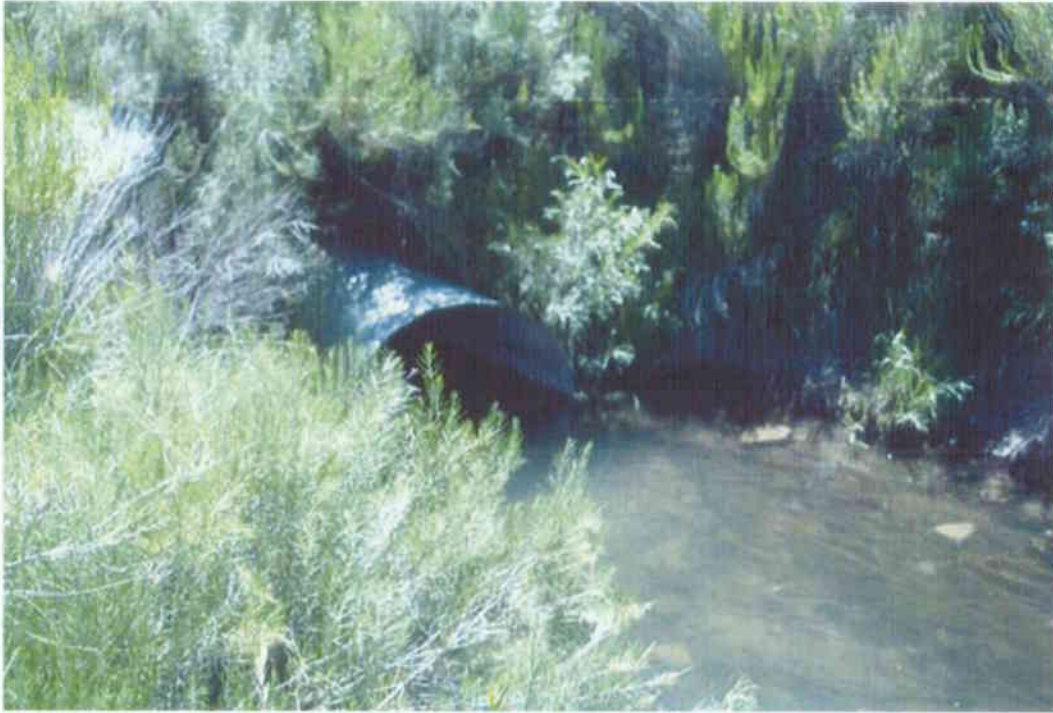
Figure 11. Turley-Manzanares Acequia, Feature 8, culvert, photo facing northwest (July 6, 2005).

Feature 8 was a culvert constructed of 36-inch-diameter corrugated steel pipe (Figure 11). The culvert was constructed after 1953 (Pat Montoya, personal communication 2006). It conveyed water beneath County Road 4399. The length of the culvert was approximately 20 ft.

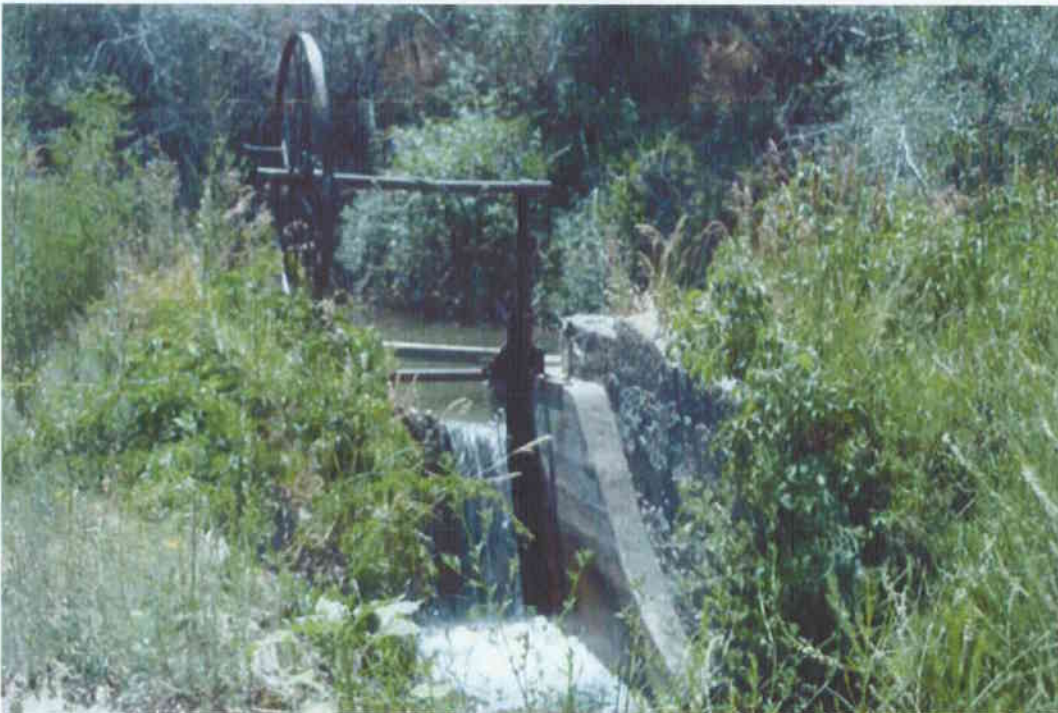
Figure 12. Turley-Manzanares Acequia, Feature 9, hay rake-wheel drain, photo facing south (July 6, 2005).

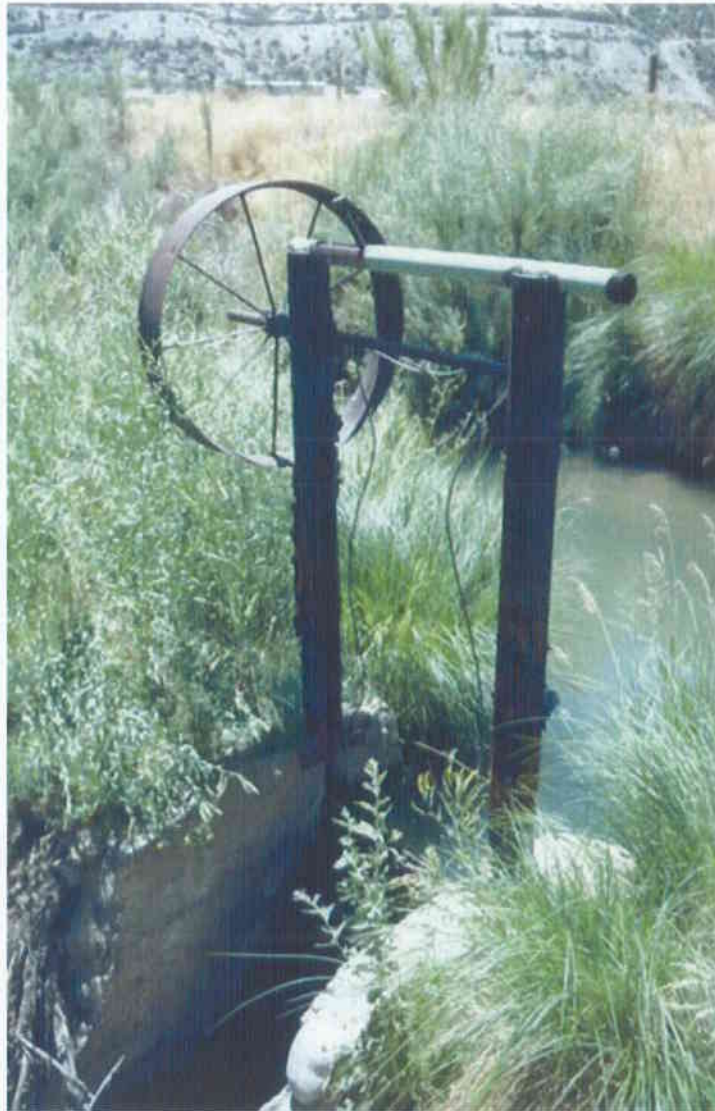
Figure 13. Turley–Manzanares Acequia, Feature 10, hay rake-wheel drain, photo facing south (July 6, 2005).

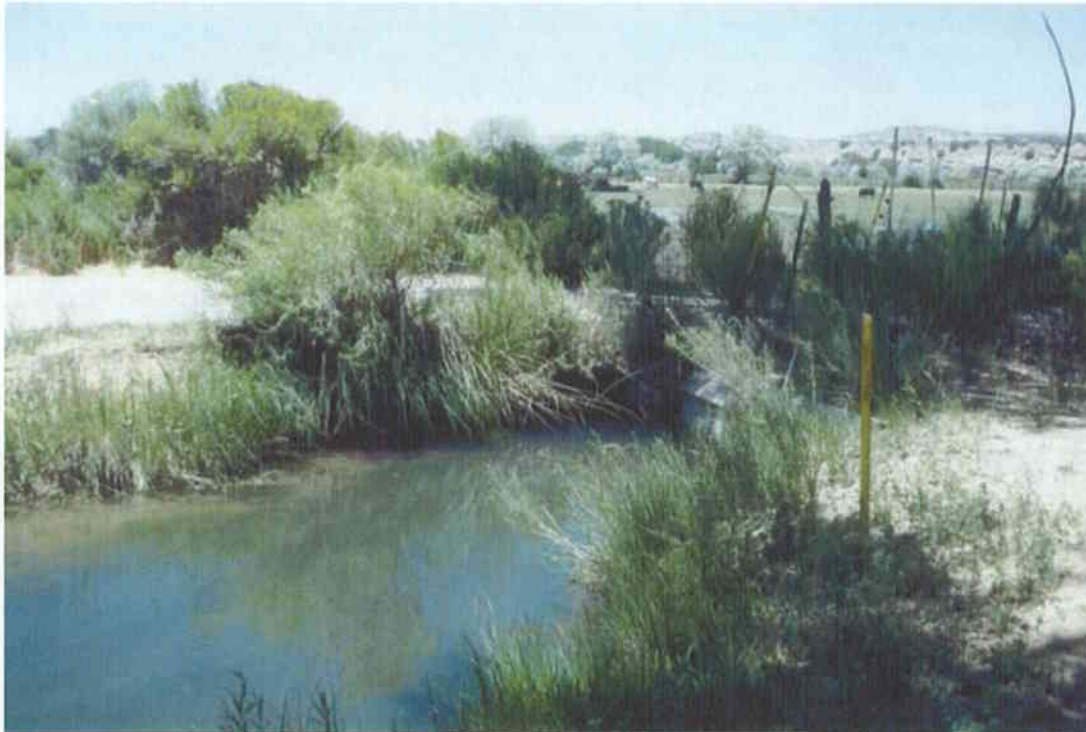
Figure 14. Turley-Manzanares Acequia, Feature 11, culvert, photo facing west (July 6, 2005).

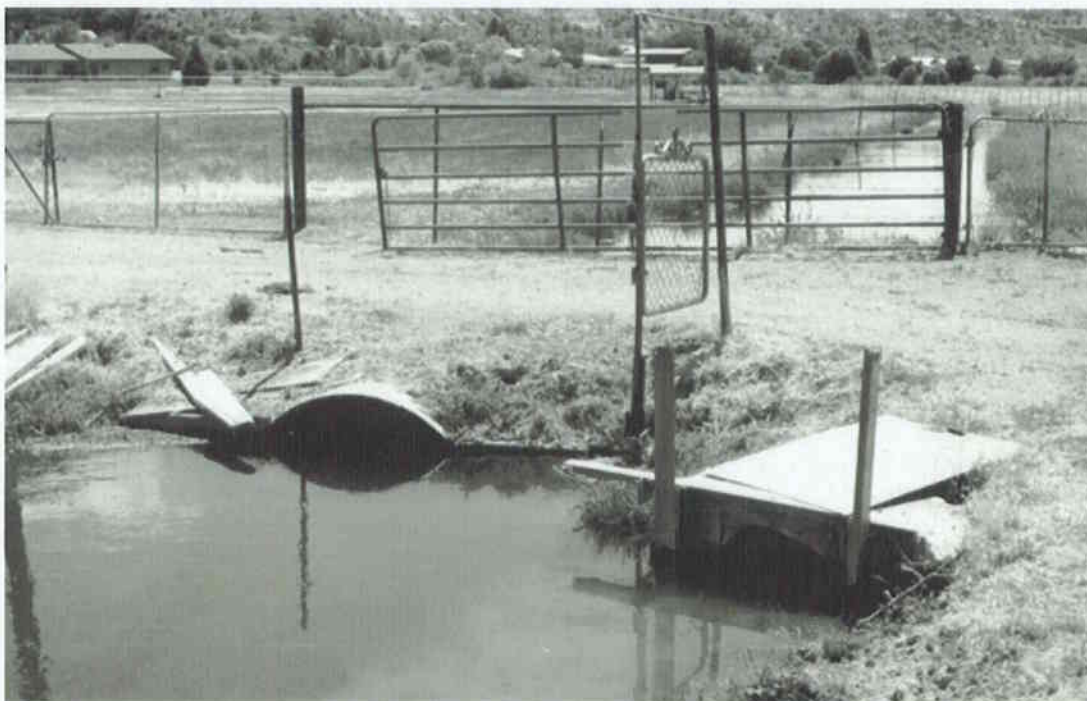
Figure 15. Turley-Manzanares Acequia, Feature 12, culvert, photo facing west.
Note modern construction of small culvert on right (July 6, 2005).

Feature 12 was a culvert constructed of 24-inch-diameter corrugated steel pipe (Figure 15). The culvert was constructed after 1953 (Pat Montoya, personal communication 2006). It conveyed water beneath a road. The length of the culvert was approximately 8 ft.

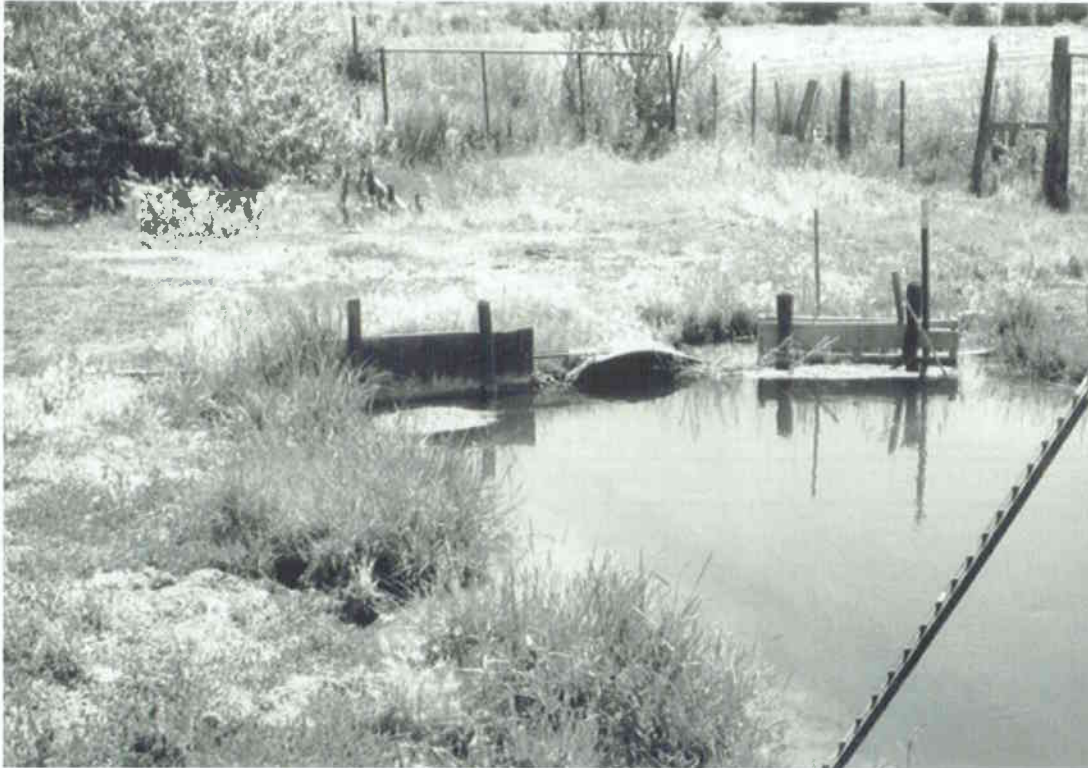
Figure 16. Turley-Manzanares Acequia, Feature 13, culvert, photo facing west (July 6, 2005).

Feature 13 was a culvert constructed of 24-inch-diameter corrugated steel pipe (Figure 16). The culvert was constructed after 1953 (Pat Montoya, personal communication 2006). It conveyed water beneath a road. The length of the culvert was approximately 8 ft.

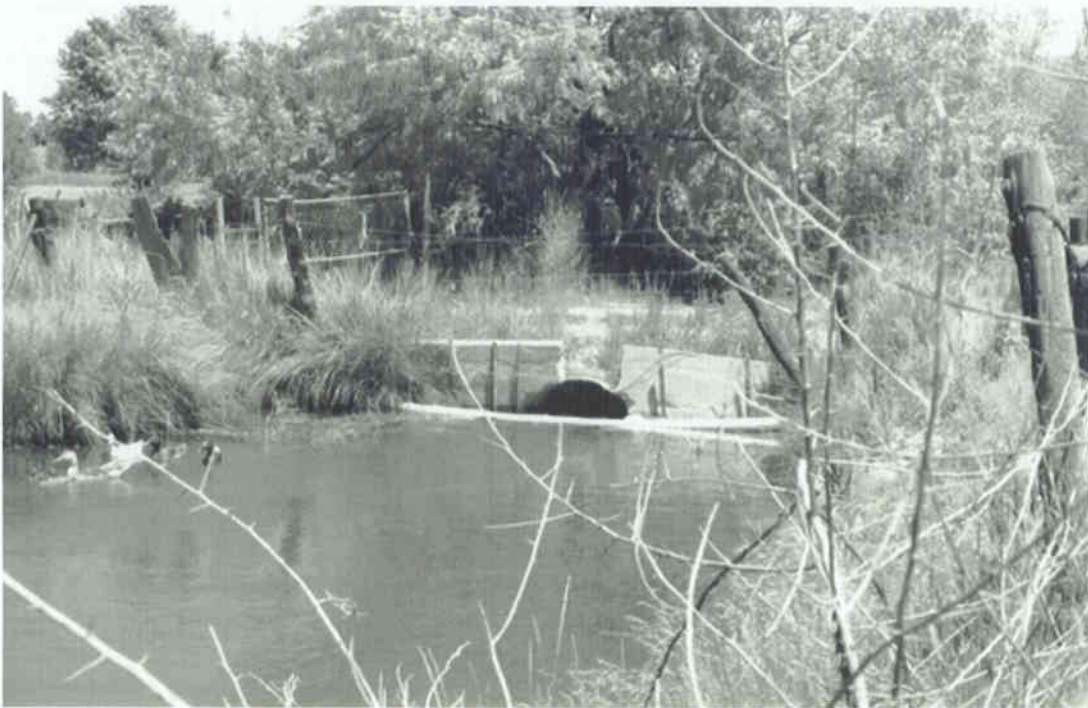
Figure 17. Turley-Manzanares Acequia, Feature 14, culvert, photo facing east (July 6, 2005).

Feature 14 was a culvert constructed of 24-inch-diameter corrugated steel pipe (Figure 17). The culvert was constructed after 1953 (Pat Montoya, personal communication 2006). It conveyed water beneath the driveway of the adjacent house. The length of the culvert was approximately 6 ft. At each end of the culvert, concrete walls were in place to hold the overlying sediments that comprised the driveway.

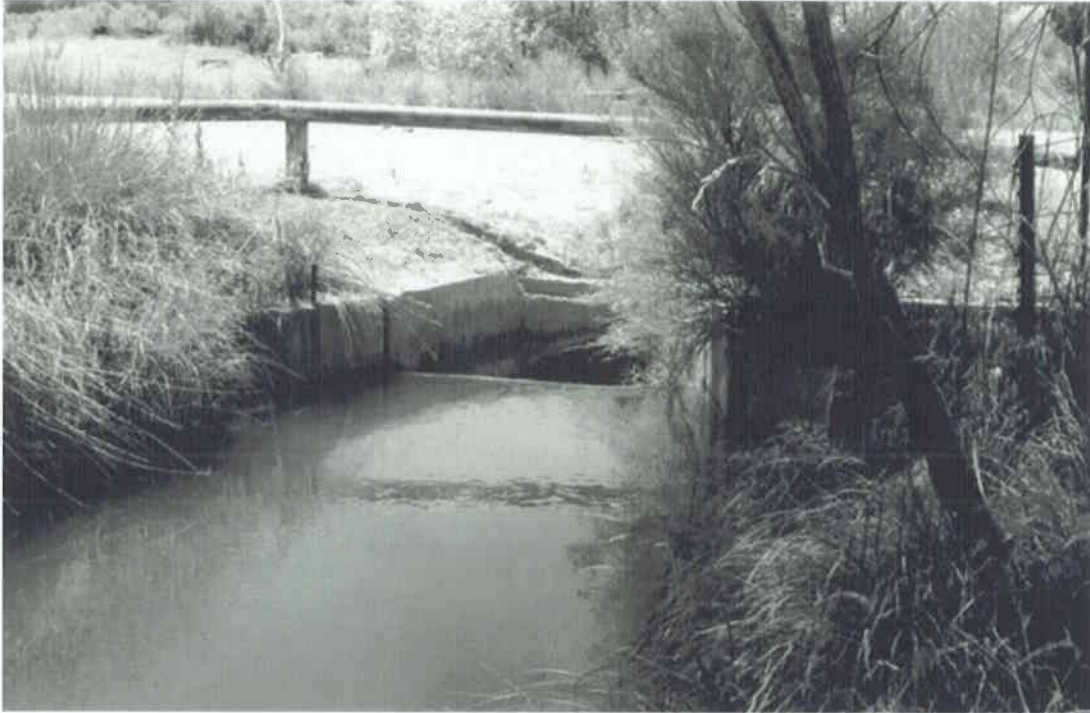
Figure 18. Turley-Manzanares Acequia, Feature 15, drop and culvert, photo facing west (July 6, 2005).

Feature 15 was a drop and culvert (Figure 18). The drop was constructed prior to 1953; the culvert has been replaced since then (Pat Montoya, personal communication 2006). Drops were constructed to permit rapid changes in the elevational gradient of water in a ditch while minimizing canal erosion (Ackerly 1996). The drop was connected to a culvert constructed of corrugated steel pipe, which carried water underneath the adjacent road.

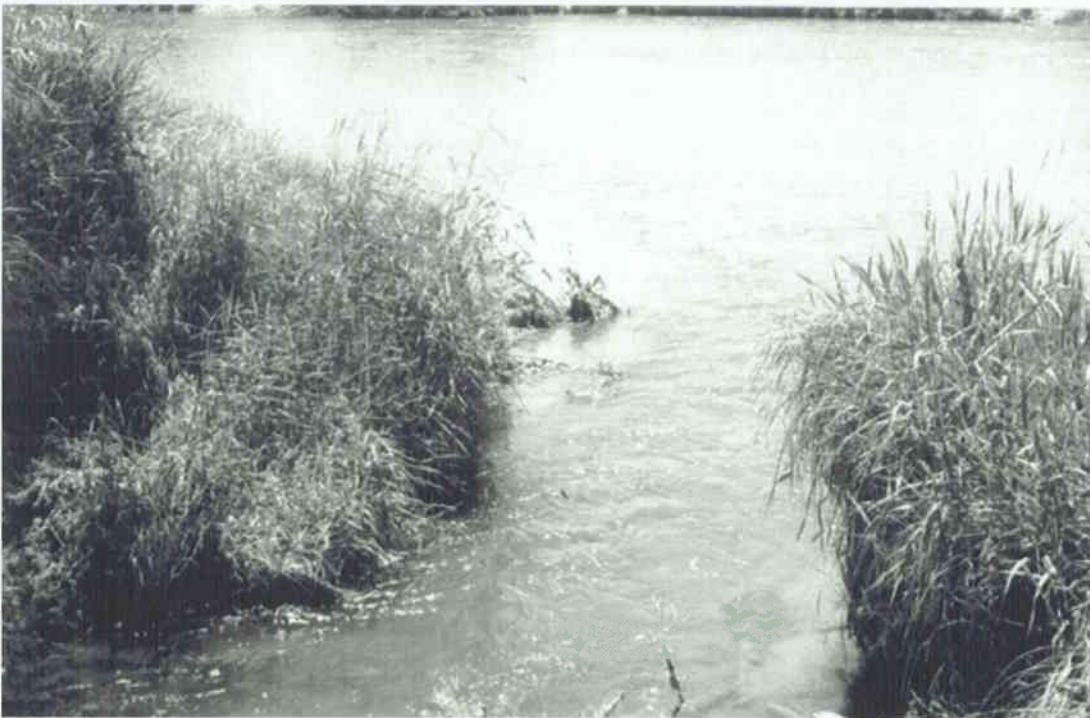
Figure 19. Turley-Manzanares Acequia, Feature 16, river return, photo facing west. Note San Juan River in background (July 6, 2005).

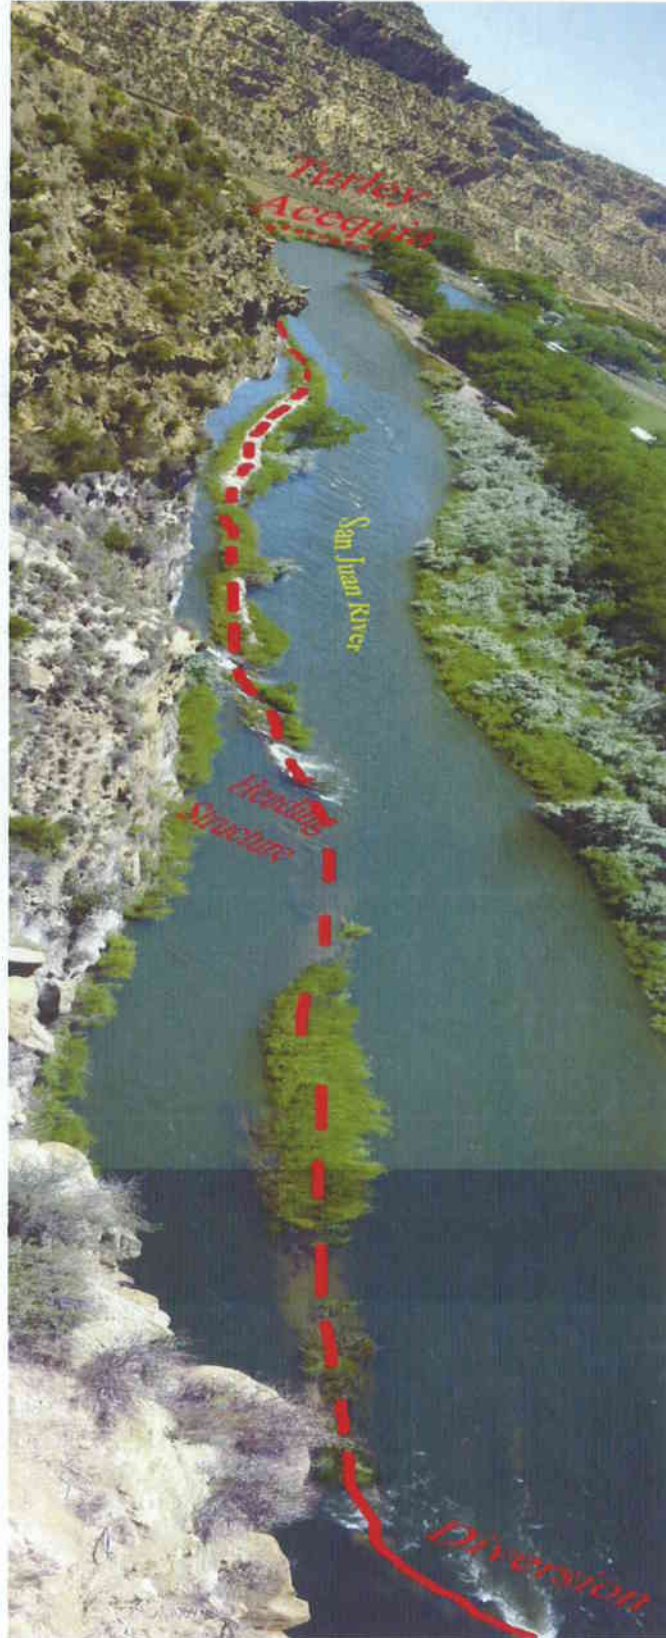
Figure 3. Diagram of the Turley-Manzanares Acequia along the San Juan River, New Mexico.
